Lessons Learned from Dike Failures in Recent Decades

ABSTRACT: *The paper describes five different dike failures that occurred in recent decades. The case histories were located on different rivers and involved different loading conditions. The observed failure mechanisms involved erosion and stability problems. The types of erosion observed were both internal erosion due to extreme groundwater flow and external erosion caused by the river flow and wave action. The case involving instability was caused by uplift, i.e., increased hydraulic head led to a sharp reduction in maximum shear strength between subsoil layers. Two cases demonstrate the importance of dike management and maintenance. Despite the variations in the loading conditions and failure mechanisms, all the cases show that the strength of a dike depends not only on the material used to build the dike but also on the strength of the subsoil.*

Lessons Learned from Dike Failures in Recent Decades. International Journal of Geoengineering Case histories, Vol.4, Issue 3, p.203-229. doi: 10.4417/IJGCH-04-03-04

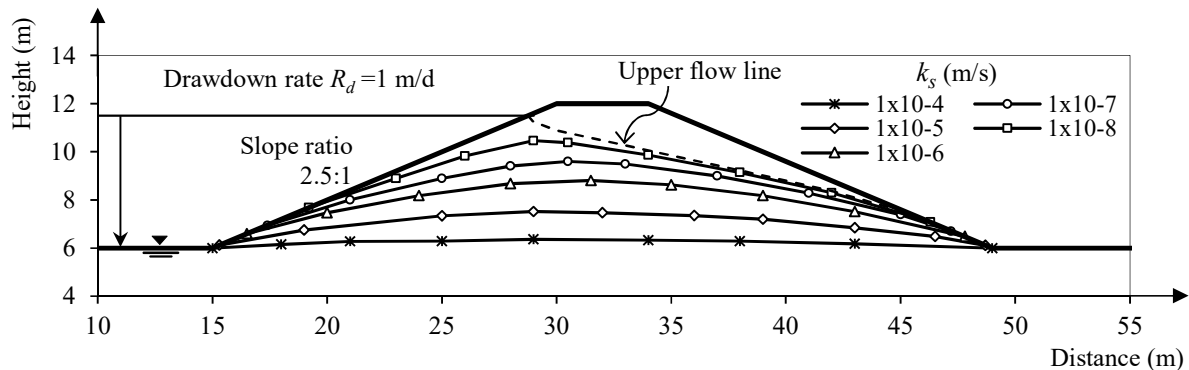
Figure 7. Phreatic surfaces (desaturation lines) at the end of the water drawdown stage in a dike with variable hydraulic conductivities k_s , (López-Acosta et al. 2015)

These analyses evaluated several homogeneous and isotropic dikes with a 2.5(H):1(V) slope and total dewatering head of 5.5 m for different hydraulic conductivities. Figure 7 shows the upper flow line for the initial steady-state condition and desaturation lines at the end of water drawdown in dikes with different hydraulic conductivities k_s for the transient-state condition and assuming a constant drawdown rate of $R_d = 1$ m/d. As can be seen from this figure, where $k_s = 1 \times 10^{-8}$ m/s, the desaturation line remains practically in the same position as the upper flow line, which is associated with the *fully rapid drawdown mode*. In this case, it can be assumed that the soil behaves undrained. For $k_s = 1 \times 10^{-4}$ m/s, the desaturation line inside the dike drops down almost in line with the reservoir water level, which is associated with the *fully slow drawdown mode*. In this case, it can be assumed that the soil behaves drained. It can also be assumed that the desaturation lines between these two extreme modes represent the *transient drawdown mode* in which a curvilinear water line is generated in the soil structure, the position of which depends on the drawdown rate and the constitutive material properties. The remaining pore pressure in the dike is therefore transient, it varies as a function of time, but also with the soil's ability to retain water. Several authors have recognised the three water drawdown modes described here (examples being Lane & Griffiths, 2000 and Berilgen, 2007).

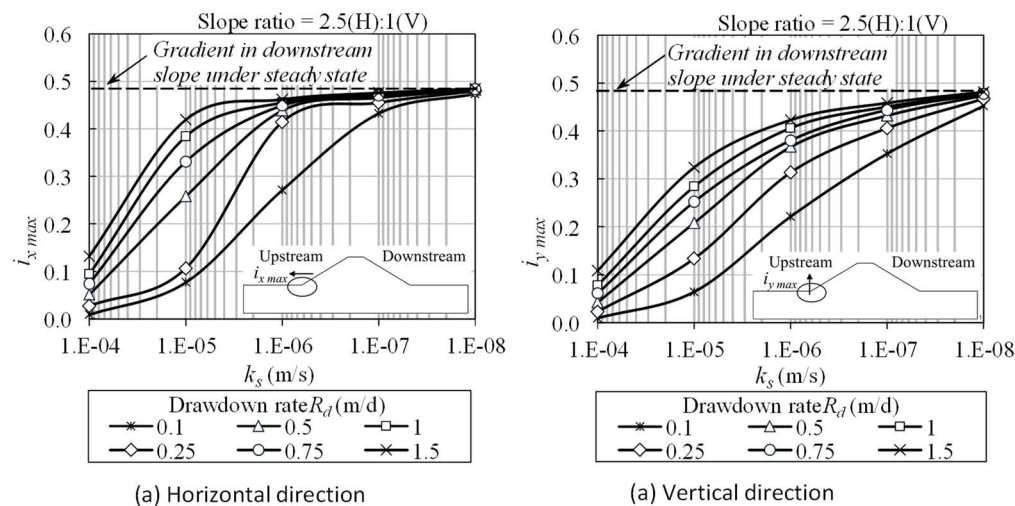
Figure 8. Effect of drawdown rate R_d on exit hydraulic gradients in dikes for variable hydraulic conductivities k_s , (López-Acosta et al. 2015)

Figure 8 shows the effect of the drawdown rate on exit hydraulic gradients in the horizontal and vertical directions, corresponding to the x and y axes respectively, in both the upstream and downstream slopes of the dikes with variable hydraulic conductivities k_s . In addition, Figure 9 summarizes the results obtained assuming variable permeabilities k_s and a constant drawdown rate ($R_d = 1$ m/d). The following conclusions can be drawn on the basis of the results of these parametric analyses:

- The exit hydraulic gradients were observed to increase when the drawdown rate increased.
- In general, given the admissible values suggested by several authors for local erosion and piping (for example, Den Adel et al., 1988; Wan & Fell, 2004; Ahlinhan & Achmus, 2010), the magnitude of the gradients computed here is significant. One suitable way of preventing internal erosion or piping is the installation of filters or drains placed strategically in the earth structure.

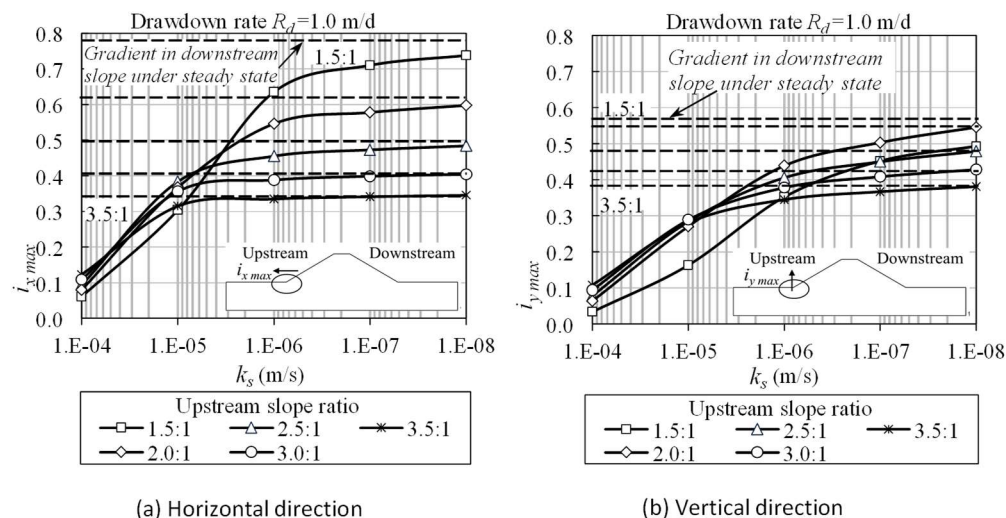
Figure 9. Effect of the slope ratio (H:V) on exit hydraulic gradients in dikes for different hydraulic conductivities k_s , (López-Acosta et al. 2015)

- Under a steady-state flow, the exit hydraulic gradients in the downstream slope remain constant for all k_s permeabilities studied.
- Changes in the slope ratio of dikes have a more significant effect on the magnitude of the exit hydraulic gradients than changes in the drawdown rate. It was observed that steeper slopes generate greater values for exit gradients.

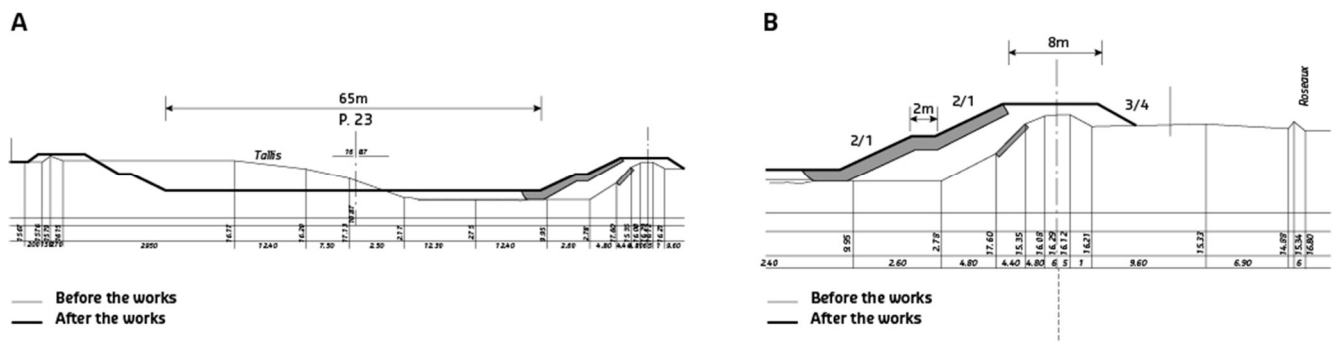
Figure 12. a) Re-profiling of the river and construction of the dikes, b) armouring of the river side of the dikes in concave sections

When the river was re-profiled in 1970, the bed was widened to 65-70 m. The dikes generally were constructed to an elevation of 2-3 m, 8 m wide at the crest, with 1V/2H slopes, see Figure 12 and were built using local material. Thus, the materials used vary along the dikes and may consist of loam and sandy loam or even gravel. There is riprap toe protection on the river side, and armour protection over the full height on the concave side of curved sections, as shown in Figure 12b.

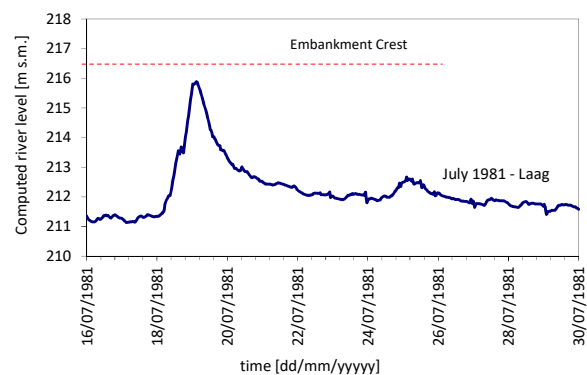
Figure 17. River level computed at Laag (km 106.185) from 16 July to 30 July 1981. The elevation of the embankment crest is reported as a reference.

The river level at Laag and St Florian was derived from hydrometer measurements upstream (Branzoll hydrometer), assuming a uniform flow between the section where the hydrometer was installed and the sections where the embankment instabilities were located. The river level computed during the flood event is shown in Figure 17 and 19. At its peak, the river level in Laag and St Florian was still approximately 50 cm below the crest of the dike (Figure 17). Failure was therefore associated with water flow through the dike and/or its foundations and the collapse involved the instability of the landside bank.

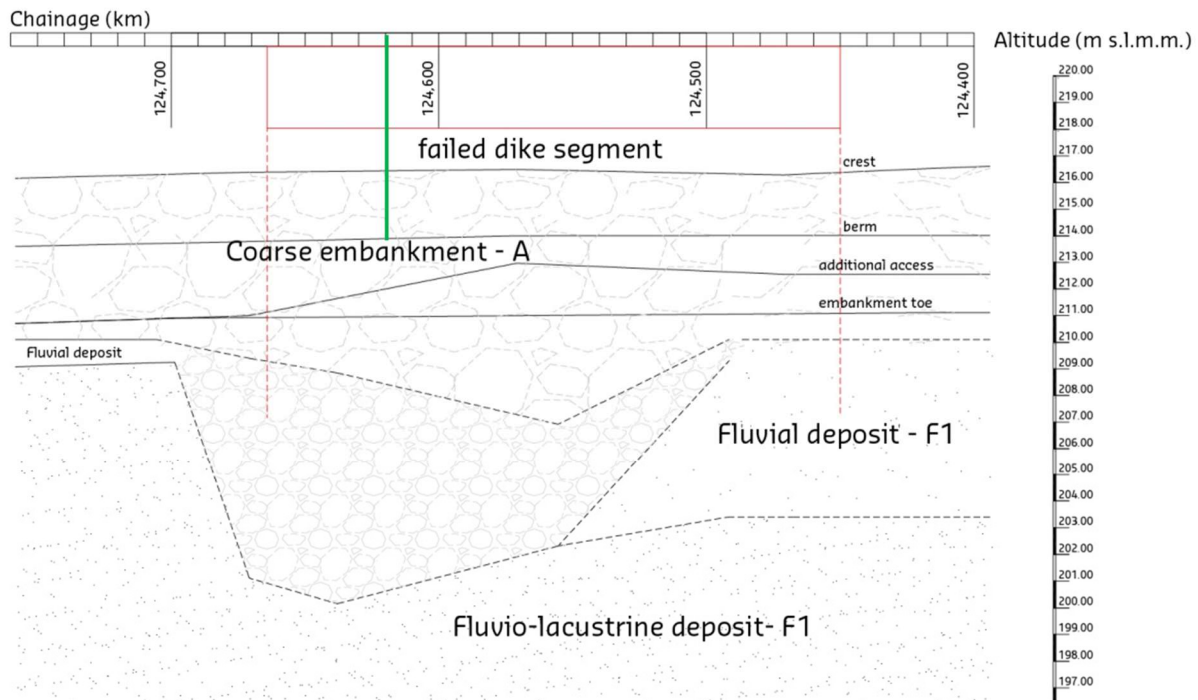
Figure 20. Longitudinal soil profile of the dike segment in Laag that includes the section breached in 1981. The location of the representative cross-section is indicated by the green line.

Figure 20 shows the longitudinal soil profile that includes the segment of the dike in Laag breached in 1981 and then reconstructed after 1981. The dip in the interface between the coarse-grained embankment and the ancient river bed is attributable to the excavation of the ancient river bed material after the dike was breached. During the flood, the embankment was patrolled frequently (a few times a day) and no evidence of sand boiling was detected. It is not possible to exclude that

sand boiling was occurring between one visual inspection and another. However, it would appear that failure was mainly caused by underseepage rather than erosion triggered by uplift pressures at the landside toe of the embankment.

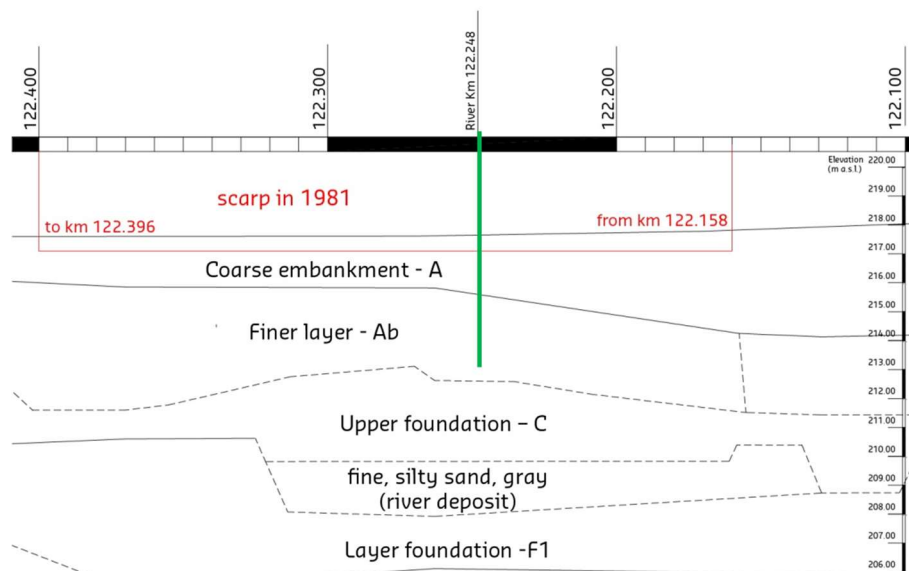
Figure 22. Longitudinal soil profile of the dike segment in St Florian that includes the portion affected by instability in 1981. The location of the representative cross-section is indicated by the green line.

The cross-section at chainage 124.620 km was selected to analyze the hydro-mechanical response of the embankment (Figure 21). Figure 22 shows the longitudinal soil profile that includes the segment of the dike in St Florian affected by instability in 1981 (scarp of about 50 cm). The cross-section at chainage 122.248 km was selected to analyze the hydro-mechanical response of the embankment (Figure 23).

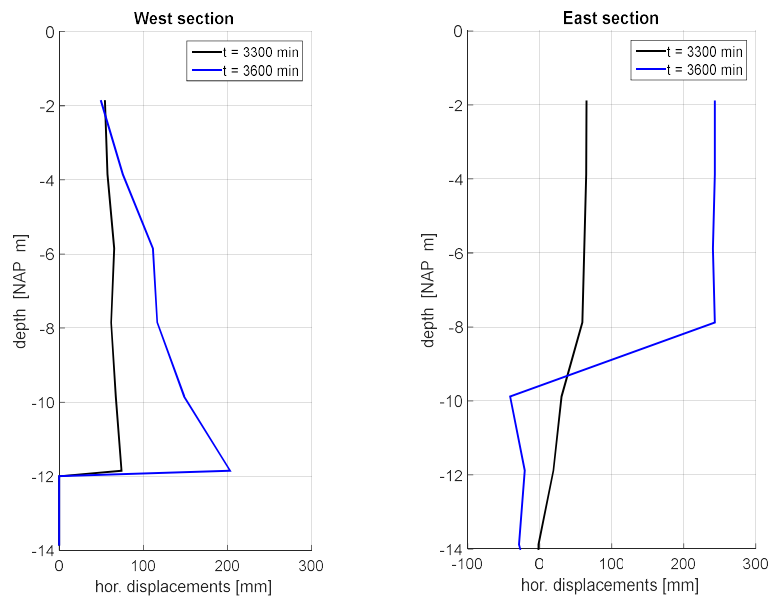
Figure 33. Horizontal displacement at the toe (both polder-side west respectively east of the central section as shown in Figure 27a)

Figure 33 shows the horizontal displacements measured at the toe in the eastern and western sections at $t = 3300$ min (55 h) and $t = 3600$ min (60 hours). Note that there was no inclinometer in the central section. The maximum displacement was found at the transition between the Pleistocene and Holocene layers, which was not at the same depth in both sections. Figure 34 shows the development of the maximum displacement for both sections. In the western section, horizontal displacements started to develop as soon as infiltration began. At approximately $t = 1500$ min, infiltration was suspended temporarily and no further deformation was observed until $t = 2500$ min, when infiltration resumed. Soon after, horizontal displacement developed in the eastern section as well. Infiltration was suspended for a second time, and horizontal displacement stopped again. Soon after infiltration resumed, displacement accelerated until the dike failed at $t = 3450$ min (57.5 hours) after the start of the test.

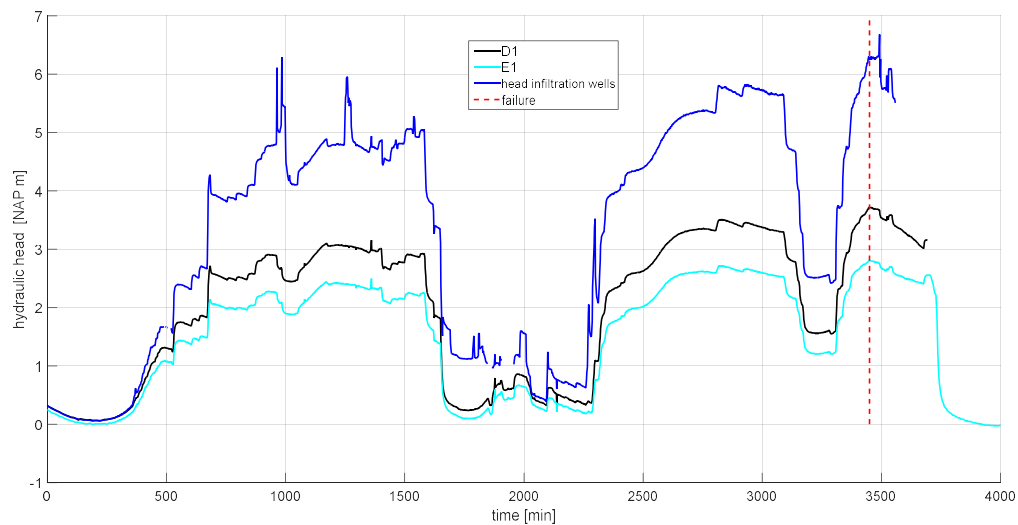
Figure 35. Hydraulic head in Pleistocene sand layer, locations D1 and E1 (see Figure 29)

Figure 35 shows the hydraulic head observed in the Pleistocene sand layer at distances of 21 and 42 m from the infiltration wells. The effect of infiltration declined with increasing distance from the well; the hydraulic head at D1 was lower than in the infiltration wells and a further reduction in maximum head was observed in E1.

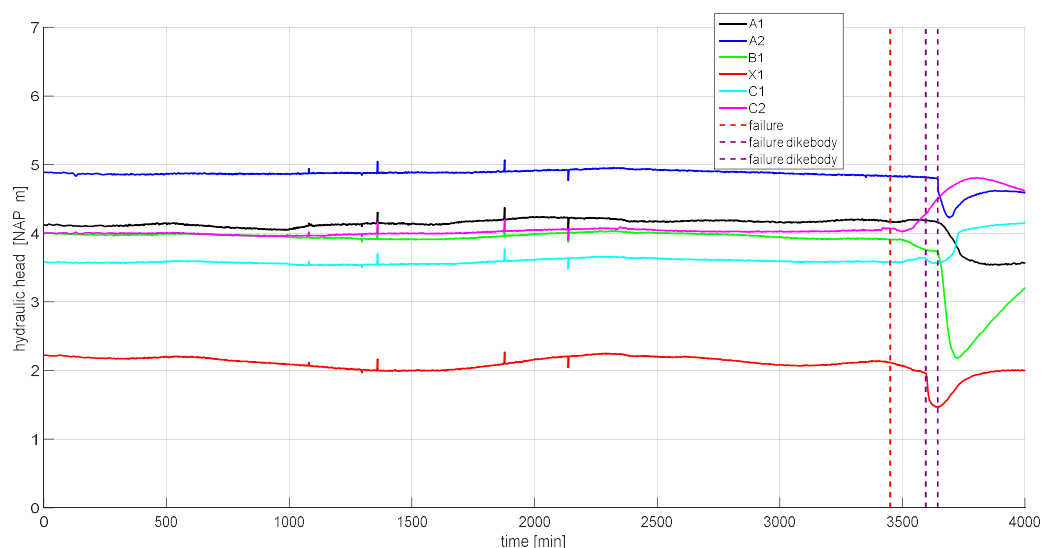
Figure 36. Hydraulic head in the dike body for locations A1 to C2 (see Figure 29)

Figure 36 shows how hydraulic head developed inside the dike body. Prior to failure there was no significant fluctuation in hydraulic head. The range in hydraulic heads measured by the different transducers can probably be explained by suction forces at the top of the dike. With the exception of C2, there was a sharp drop indicating failure. Close inspection shows that, inside the dike body, the response to failure was later than given by the observed horizontal displacement at the toe, $t = 3450$ min at which only the pore pressure at location C2 shows a response. There was a minor initial response at B1 and C1 shortly after $t = 3450$ min. The sharp drop in hydraulic head was observed later. The drop at X1 and C1 was observed at $t = 3595$ min, or 145 min (2.4 hours) later. At $t = 3644$ min (50 minutes later) the hydraulic head at B1 and A2 dropped significantly. The time differences for local failure found at different locations shows the propagation of the failure plane, starting deep in the subsoil and moving towards the crest. It should be noted that the development of the failure plane resulted in breakage of the infiltration wells. When infiltration ceased, the uplift conditions were no longer in place and sliding along the slip plane as indicated by Figure 28 stopped.

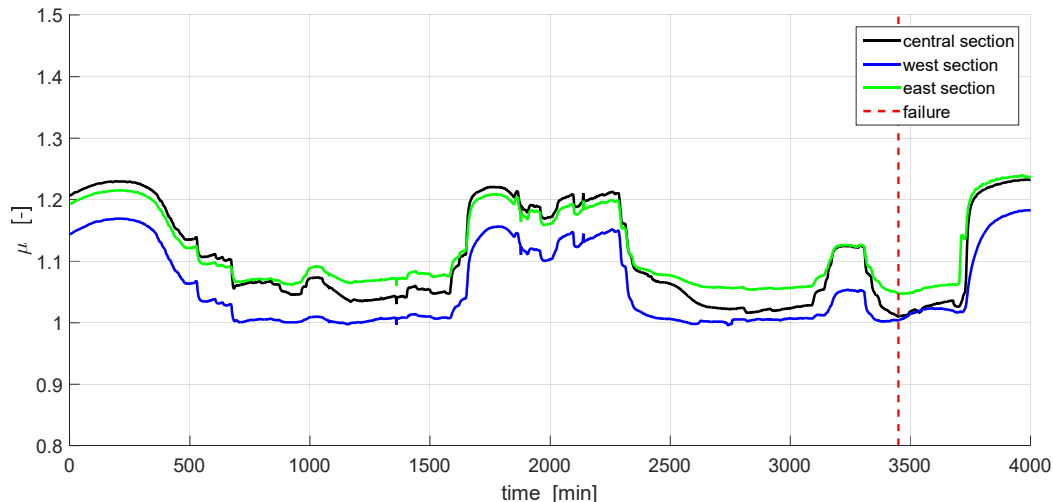
Figure 37. Ratio of total overburden pressure to pore pressure, μ , during the test

To check on the uplift conditions during the test, the ratio, μ , of the weight of the Holocene layer to pore pressure in the Pleistocene sand layer was determined for each of the transducers in the Pleistocene sand layer. Figure 37 shows the ratio, μ , during the test for the transducers placed at 46 m from the crest of the dike in the central, eastern and western sections. Initially, $\mu = 1.2$. When infiltration began, this value reduced, as expected. Due to differences in the subsoil layer, μ varied for the different sections, with the lowest value in the western section, where the value remained approximately 1. In the central and eastern sections, μ seemed to reduce slightly during the test. This corresponds to the slight increase in infiltration pressure during the test, as shown in Figure 35. The value did not drop significantly below 1.0. This could be explained by the pumping capacity, which does not allow for any further increase in pore pressure in the sand layer at the toe of the dike. It can also be hypothesized that when the pore pressure in the sand layer starts to exceed the weight of the clay and peat layers above it, a gap is created which is filled with pore water from the sand layer until a new equilibrium is attained. When pumping capacity is further increased, the gap may be widened, maintaining the equilibrium in vertical forces. In this hypothesis, $\mu = 1.0$ could be a physical boundary that will have prevented any further decline in the μ value in the western section during the test. It should be noted that, at larger distances from the dike, the Pleistocene hydraulic head decreased, causing an increase in μ . Close to the dike, μ is affected by the weight of the dike body.

Figure 33 shows that horizontal displacement in the western section was initially higher than in the eastern section. This corresponds well to the lower μ -value found for the west section, indicating that uplift was reached at an early stage of the test in the western section. The dike was seen to fail when the μ -value reached the lowest level during the test in the central section, $\mu = 1.01$, and eastern section, $\mu = 1.05$.

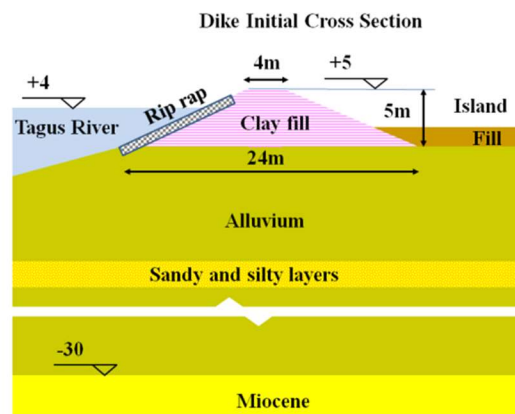
Figure 39. Initial dike cross-section and geotechnical profile.

Given the location of the island in the Tagus River delta, one of the widest estuaries in Europe, the geological scenario is very complex: alluvium deposits, mainly very soft clays, with S_u not greater than 20 kPa, sometimes interbedded with silty and sandy layers, with an overall depth of approximately 30 m (Figure 39). The alluvium rests on the bedrock of Miocene sandstone.

The main failure mechanism is related to the erosion of the clay fill due to water inflow and the mechanical action of the waves on the outer face of the dike. Failure originated with the erosion of the riprap revetment (Figure 39). The presence of a permeable sandy layer below the dike foundations also contributed to the failure mechanism. The actual dike failure began during the severe winter of 2015 - 2016 and involved a section with an overall length of approximately 30 m. When the failure occurred, the water level in the Tagus River was approximately Mean Sea Level, MSL, +4.20 m. In October 2016, the overall length of the dike failure line had increased to approximately 80 m.
